Environmental Technology Verification Report
of the
Low-Cost Stormwater BMP Study

Civil Engineering Research Foundation's Verification Statement for the Low-Cost Stormwater BMP Study

Technology Type:	Stormwater Treatment Technology
Application:	Catchbasin Insert Stormwater Treatment
Technology Name:	Catchbasin Insert BMPs
Company:	AbTech, Industries
Address:	4110 N. Scottsdale Rd. Suite 235 Scottsdale, AZ 85251
Phone:	800-545-8999
URL:	http://www.abtechindustries.com/
Company:	PacTec, Inc.
Address:	PO Box 8069 Clinton, LA 70722
Phone:	800-272-2832
URL:	http://www.drainpac.com/
Company:	GeoTechnical Marine Corp. Advanced Aquatic Products International, Inc.
Address:	1107 Key Plaza #201 Key West, FL 33040
Phone:	305-292-3070
URL:	http://www.Hydro-Cartridge.com
Company:	AquaShield, Inc.
Address:	2733 Kanasita Dr. Chattanooga, TN 37343
Phone:	423-870-8888
URL:	http://aquashieldinc.com/

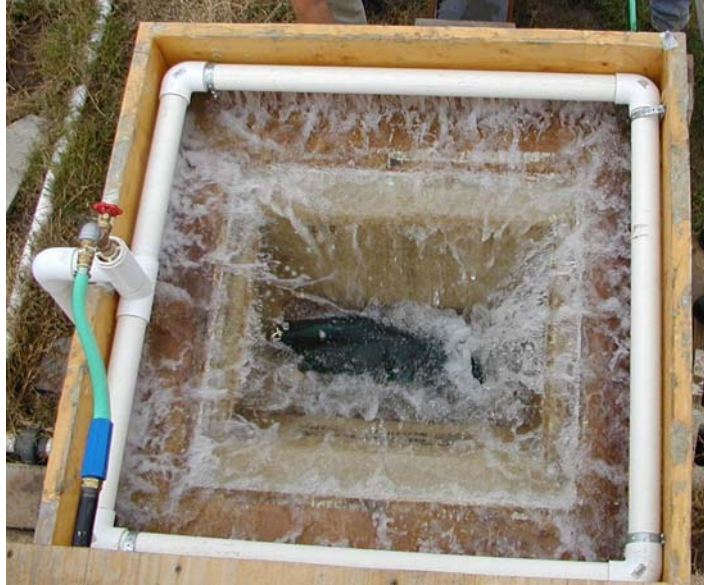
Figure 3. Top view of simulated catchbasin.

The water was distributed around the periphery of the catch basin in a 5.08-cm (2-in) manifold with 1.3 cm (0.5 in) orifices at 2.54 cm (1.0 in) centers (see Figure 3). The water ran a short distance over a platform on the simulator, then fell over the edge of the catch basin into the insert. This distribution system allowed the system to simulate weir flow into the insert and also allowed for maximum use of the insert material for treatment of the waste.

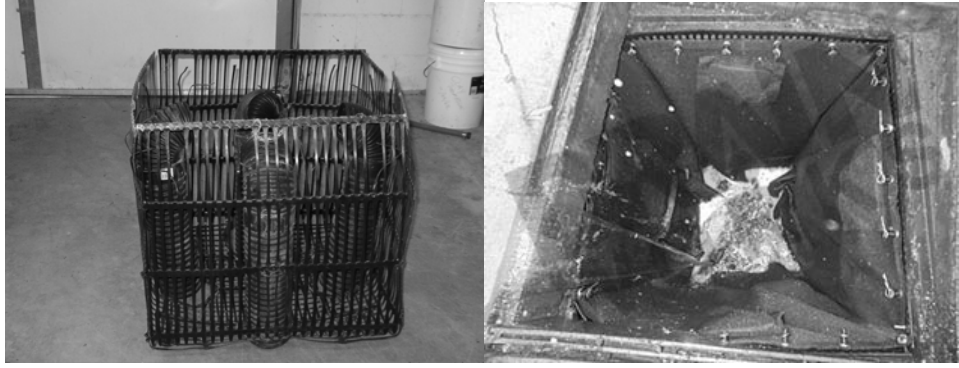
Figure 6. DrainPac catchbasin insert.

The DrainPac insert is constructed of metal frame to which a plastic mesh is suspended. The metal collar can be constructed to set on the catchbasin frame or to be attached to the catchbasin walls. Set inside of the plastic mesh, a bag filter is placed provide both straining and absorption (Figure 6). Water flows into the insert through the catch basin grate and into the top of the insert. Water flows through the bag filter and then is discharged out of the bottom of the insert. Water ponds in the insert to a point where the available head was enough to push the water through the filter bag. When the flowrate was higher than could be forced through the filter bag then water bypasses the insert by flowing out of four overflow tubes.

Treatment processes used in the DrainPac insert are straining, sedimentation, and absorption. The bag filter provides straining and absorption. Settling occurs within the filter bag volume. The DrainPac insert tested was 50.8 cm (20 in) deep and the water surface area at the throat of the insert was 3,123 cm² (3.36 ft²)
